Service Bulletin

Ref. No. : EG-6009

Subject : DTC P1345/1349 - VVT-I SYSTEM MALFUNCTION - VVT CONTROLLER INSTALLATION

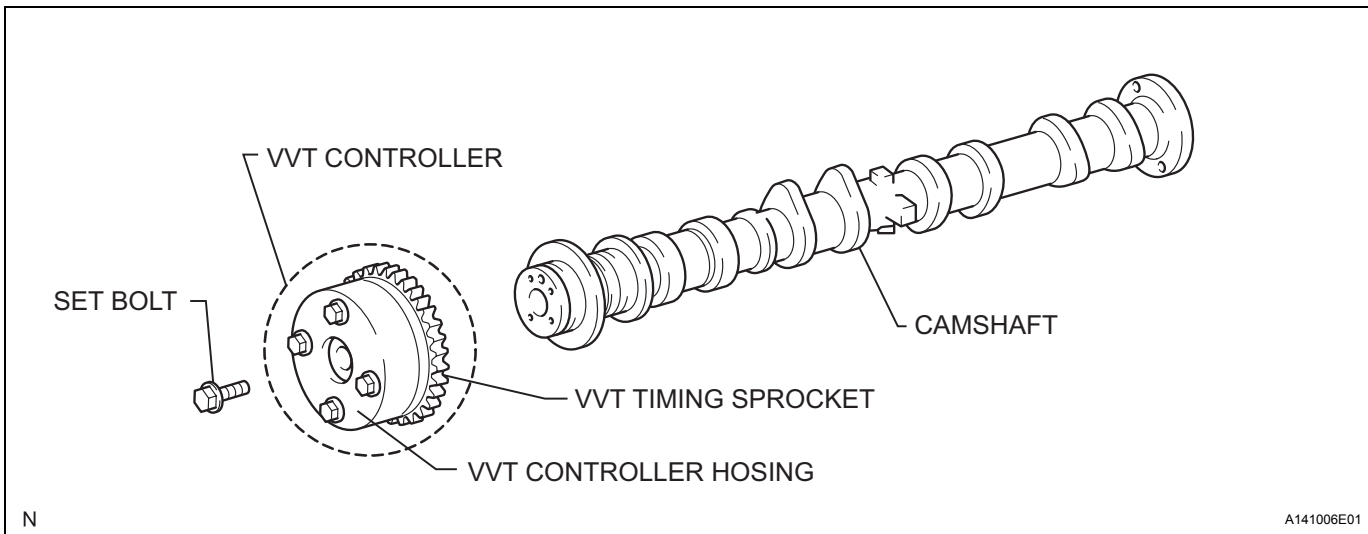
The "VVT controller" is installed on the camshaft by tightening the "set bolt". During the tightening of the set bolt, it is absolutely necessary that the "VVT timing sprocket" doesn't rotate relatively to the "VVT controller".

- If during the tightening of the "set bolt" [1.], the "VVT controller housing" rotates relatively (clockwise) to the "VVT timing sprocket", the VVT controller is locked in the retarded position by the "lock pin".
- If the set bolt is then more tightened, a high shear force is applied to the lock pin [2.].
- This causes a slight tilting of the lock pin in its bore and finally a complete jamming of the lock pin [3.].
- The lock pin cannot be disengaged anymore by the oil pressure.
 - (a)VVT controller cannot rotate intake camshaft
 - (b)Big difference between target and actual adjustment angle

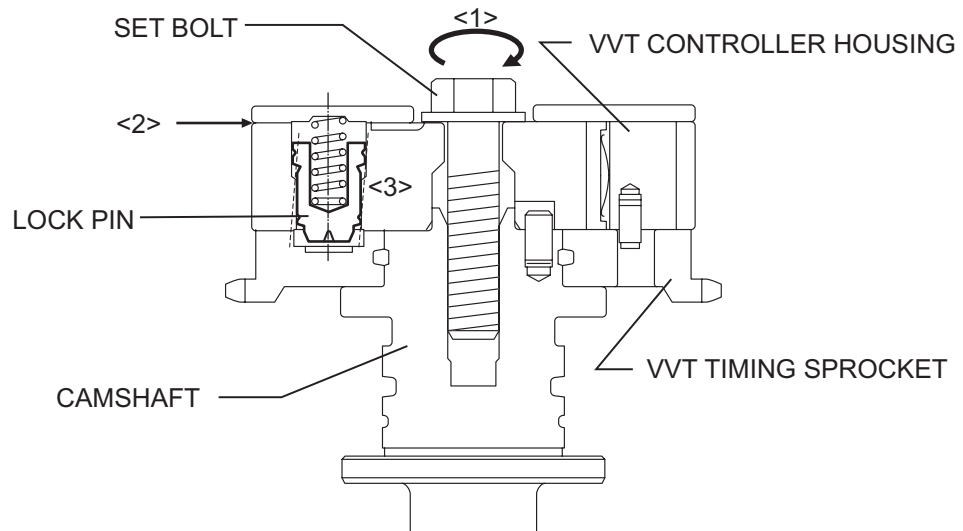
A145926E01

(c)DTC P1345 or P1349
